Insider's Guide

Line Chillers

Troubleshooting Draught Temperature Issues

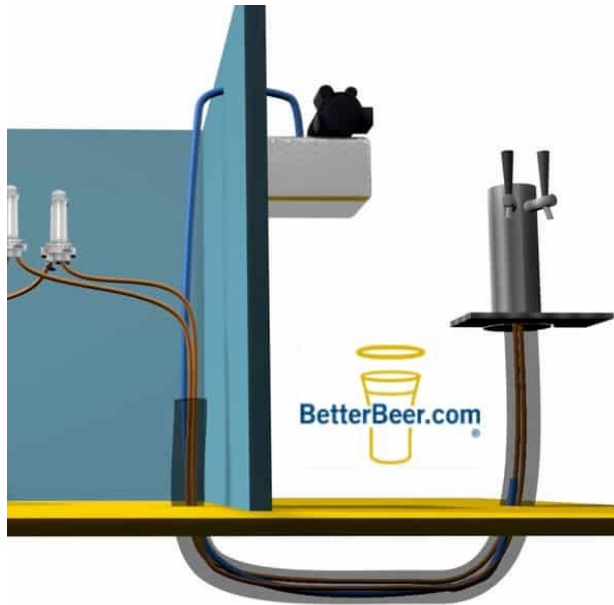
The Line Chiller (aka Power Pack or Glycol Deck) is responsible for keeping beer cold inside the trunk line. It is important to know that the Line Chiller keeps cold beer cold, it doesn't make warm beer cold. The beer that enters the trunk should be cold, thus the importance of a cold walk-in fridge. Just to be clear, cold is defined as 3°C (38°F).

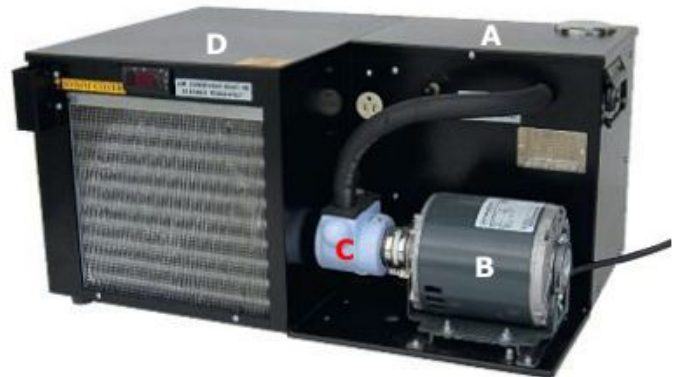
Bath (A) – The glycol (concentrate and water) gets poured into the bath, which is a small tank behind the pump and motor in this deck.

Pump & Motor – the grey cylinder is the motor (B) which spins the pump (C). This is what pushes the glycol from the bath into the trunk and back into the bath.

Compressor (D) – behind the grey screen on the left of the deck is a compressor that chills the glycol in the bath.

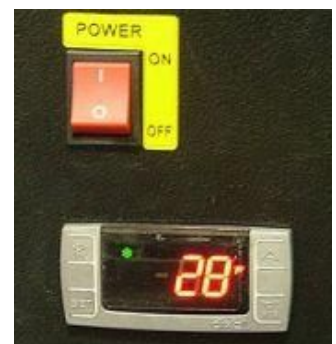
Thermostat

On the front of the deck is a LED display that will show the temperature of the glycol inside the bath. This number should be between 28 and 33. Typically, there is a six-degree swing between the bath temperature and the tap temperature. If the bath is at 28, the tap temp will usually be 34. The Molson Sub Zero system and some larger, high powered systems are the exceptions to this rule, but for the most part, you are looking for 28-33 on the reading.

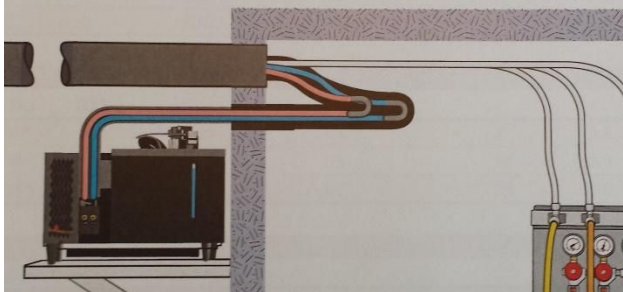
Inside the fridge – The “U” Bend

The supply and return lines leave the deck and go into the fridge, close to where the trunk line exits the fridge. The supply and return lines enter the trunk while it is still inside the fridge to ensure that there are no warm (or non-chilled) areas of the beer lines.

The deck is too cold because someone set the thermostat that controls the temperature of the bath too low or it is broken and needs to be replaced. The freezing typically happens at the U-bend in the fridge as this is where the supply line is the coldest. It is usually light beers or Guinness (lower alcohol %) which freeze first. If it happens occasionally, you can trip the breaker that powers the deck leaving it off for about an hour to thaw. The refrigeration tech should be called to adjust or replace the

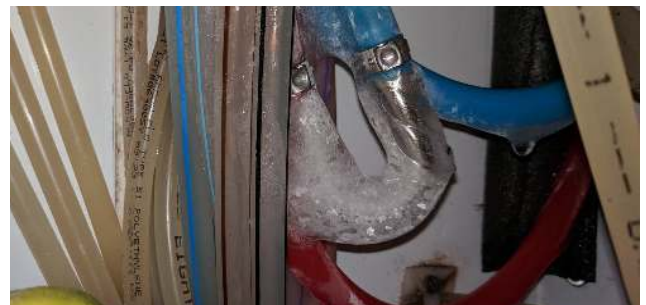
It is imperative that every inch of supply and return lines be covered in insulation so not to become covered in ice, which makes them less efficient.
